# Manhole Inspection Summary

Manhole # **S15GG\_023MH**

**Location** Address: **1611 ASHBURTON ST**

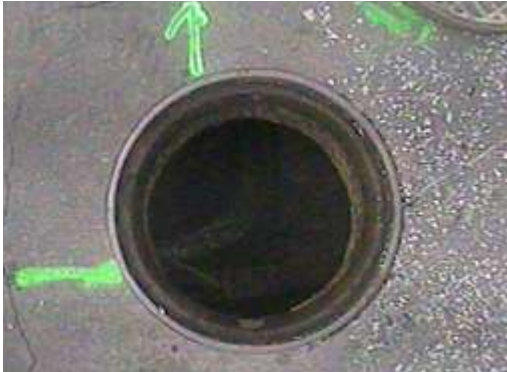
Top View

Offset: **1** (in.)

offset frame

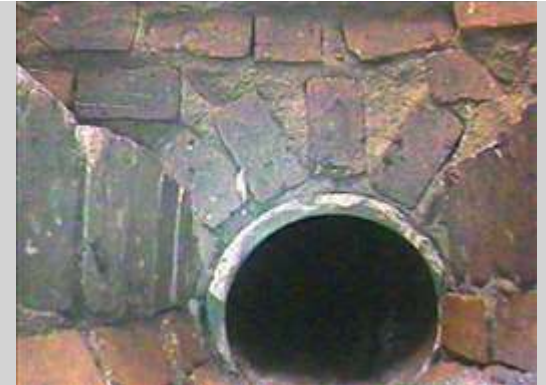
12 O'Clock Outflow

8 in. Circular Gravity Sewer  
Pipe Out @ 12 O'Clock

Pipe Height: (in.) Direct  
Pipe Material: **Clay** ☐ Pipe Lined  
Invert Depth: **6.25** (ft.) Flow Characteristics: **Fast**  
Deposits: ☒ None ☐ Mud ☐ Sludge ☐ Debris ☐ Grease  
Silt Depth: (in.) Deposits Extent:  
Infiltration: **None** Pipe Seal Cond: **Sound**

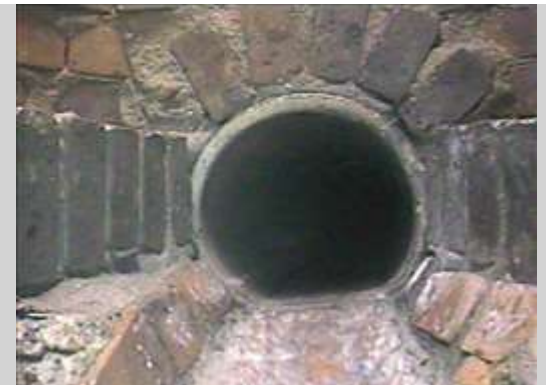
9 O'Clock Inflow

8 in. Circular Gravity Sewer  
Pipe In @ 9 O'Clock

Pipe Height: (in.) Direct  
Pipe Material: **Clay** ☐ Pipe Lined  
Invert Depth: **6.00** (ft.) Flow Characteristics: **Fast**  
Deposits: ☒ None ☐ Mud ☐ Sludge ☐ Debris ☐ Grease  
Silt Depth: (in.) Deposits Extent:  
Infiltration: **None** Pipe Seal Cond: **Sound**
